Re: **Damaged Structure (Old Island Squire)**
75 Middle Country Road, Middle Island
Middle Island, NY 11953
SCTM #0200-431-02, Lots 10 & 12

REPORT OF FINDINGS

75 MIDDLE COUNTRY ROAD
MIDDLE ISLAND, NEW YORK 11953
SCTM #0200-431-2-10 &12

DECEMBER 5, 2014

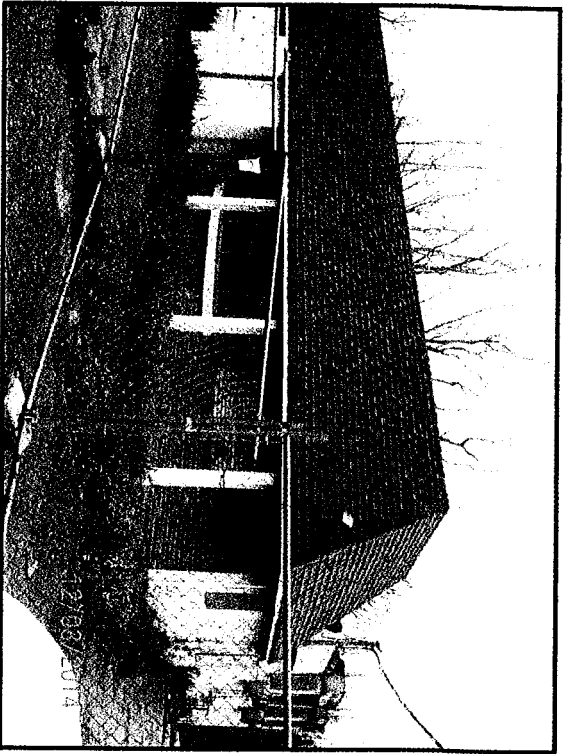
1. Exterior front view, east side

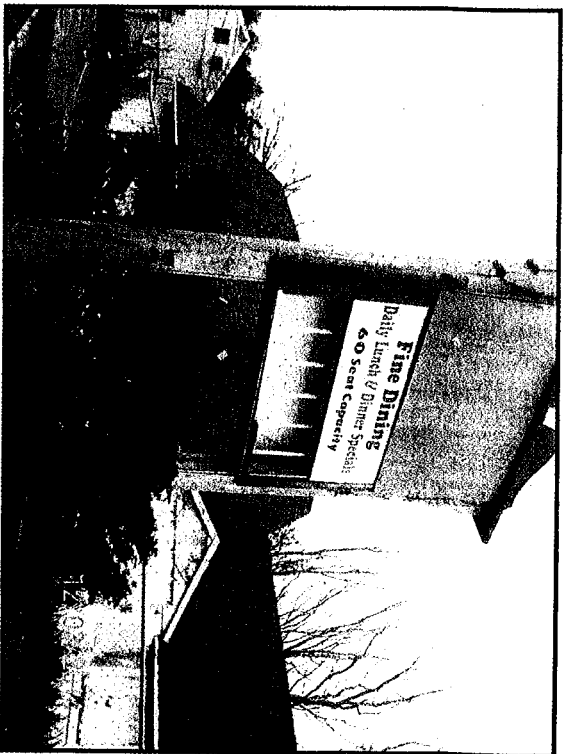
2. Front view with sign to be removed

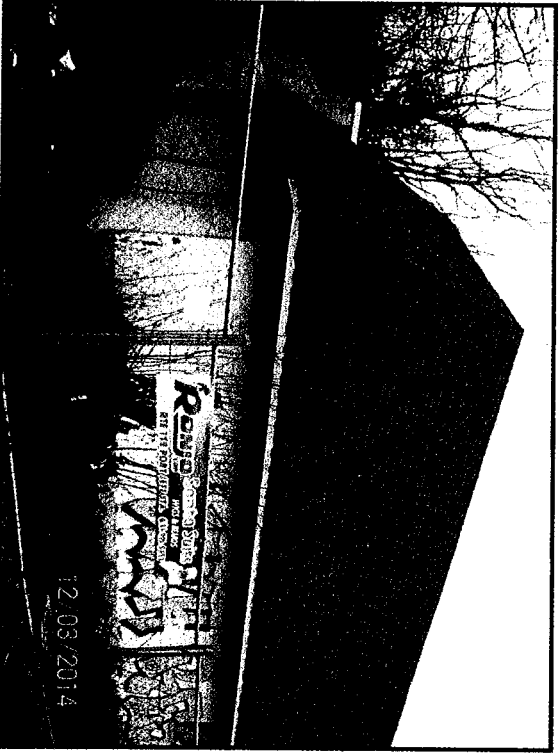
3. Exterior front view, west side

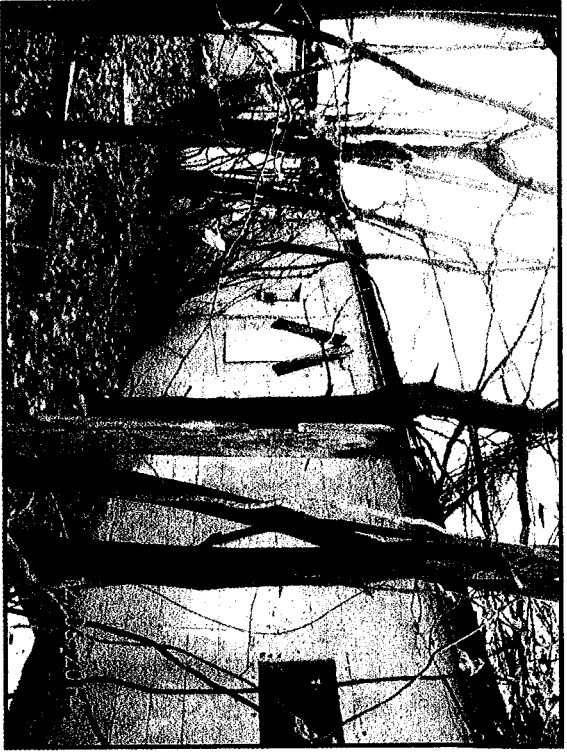
5. Exterior rear view

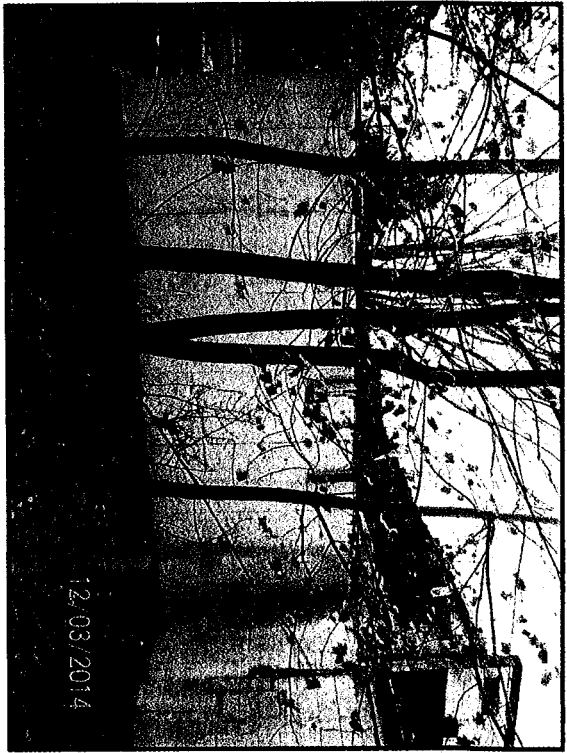
6. Exterior rear view with walk-in coolers

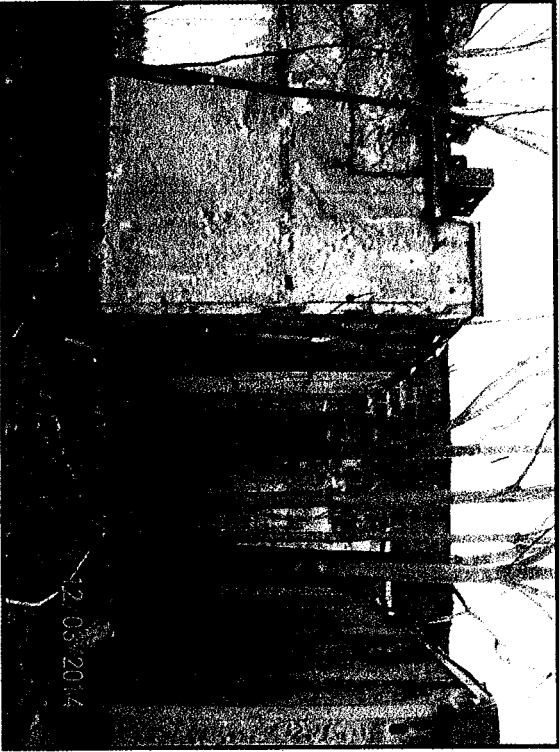
7. Exterior rear view between the two walk-in coolers

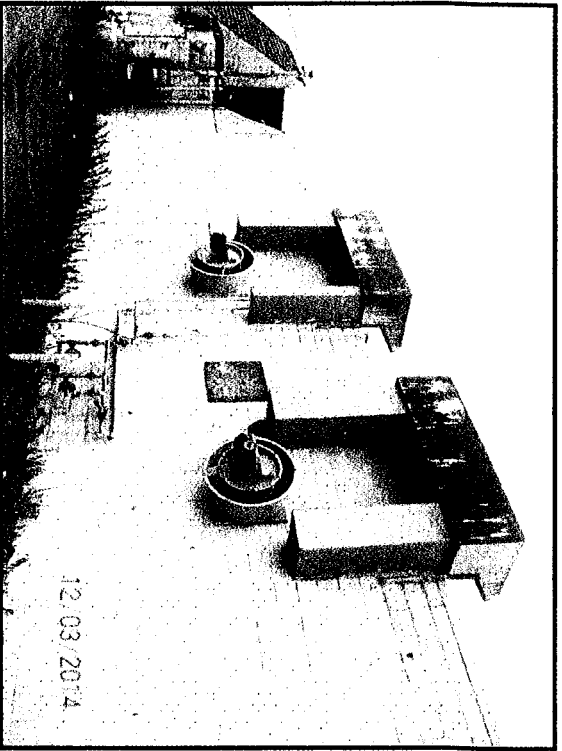
9. Exterior view, east side, shows gas and electric services

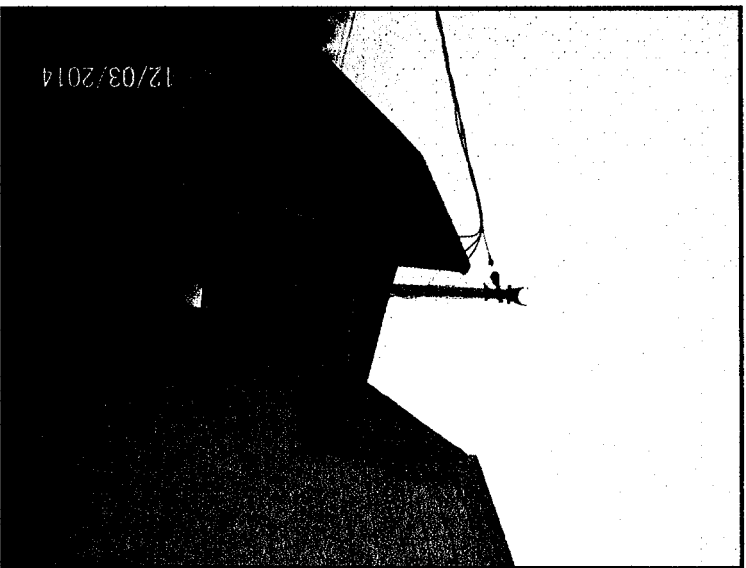
10. Exterior view, east side, shows electric service

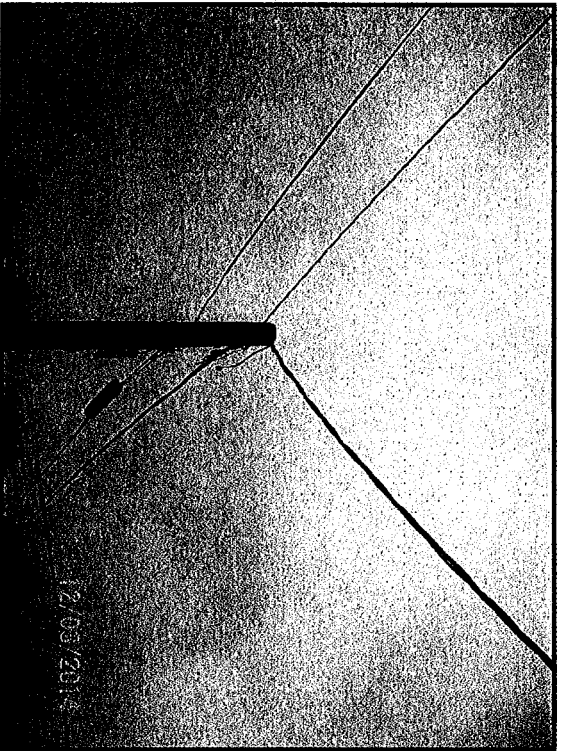
11. LIPA pole with electric service disconnected
